**St Clair River Rail Tunnel, Sarnia  
Evolution of the Design and Construction Methods  
for the TBM Cutterhead Retrieval**

**Abstract**

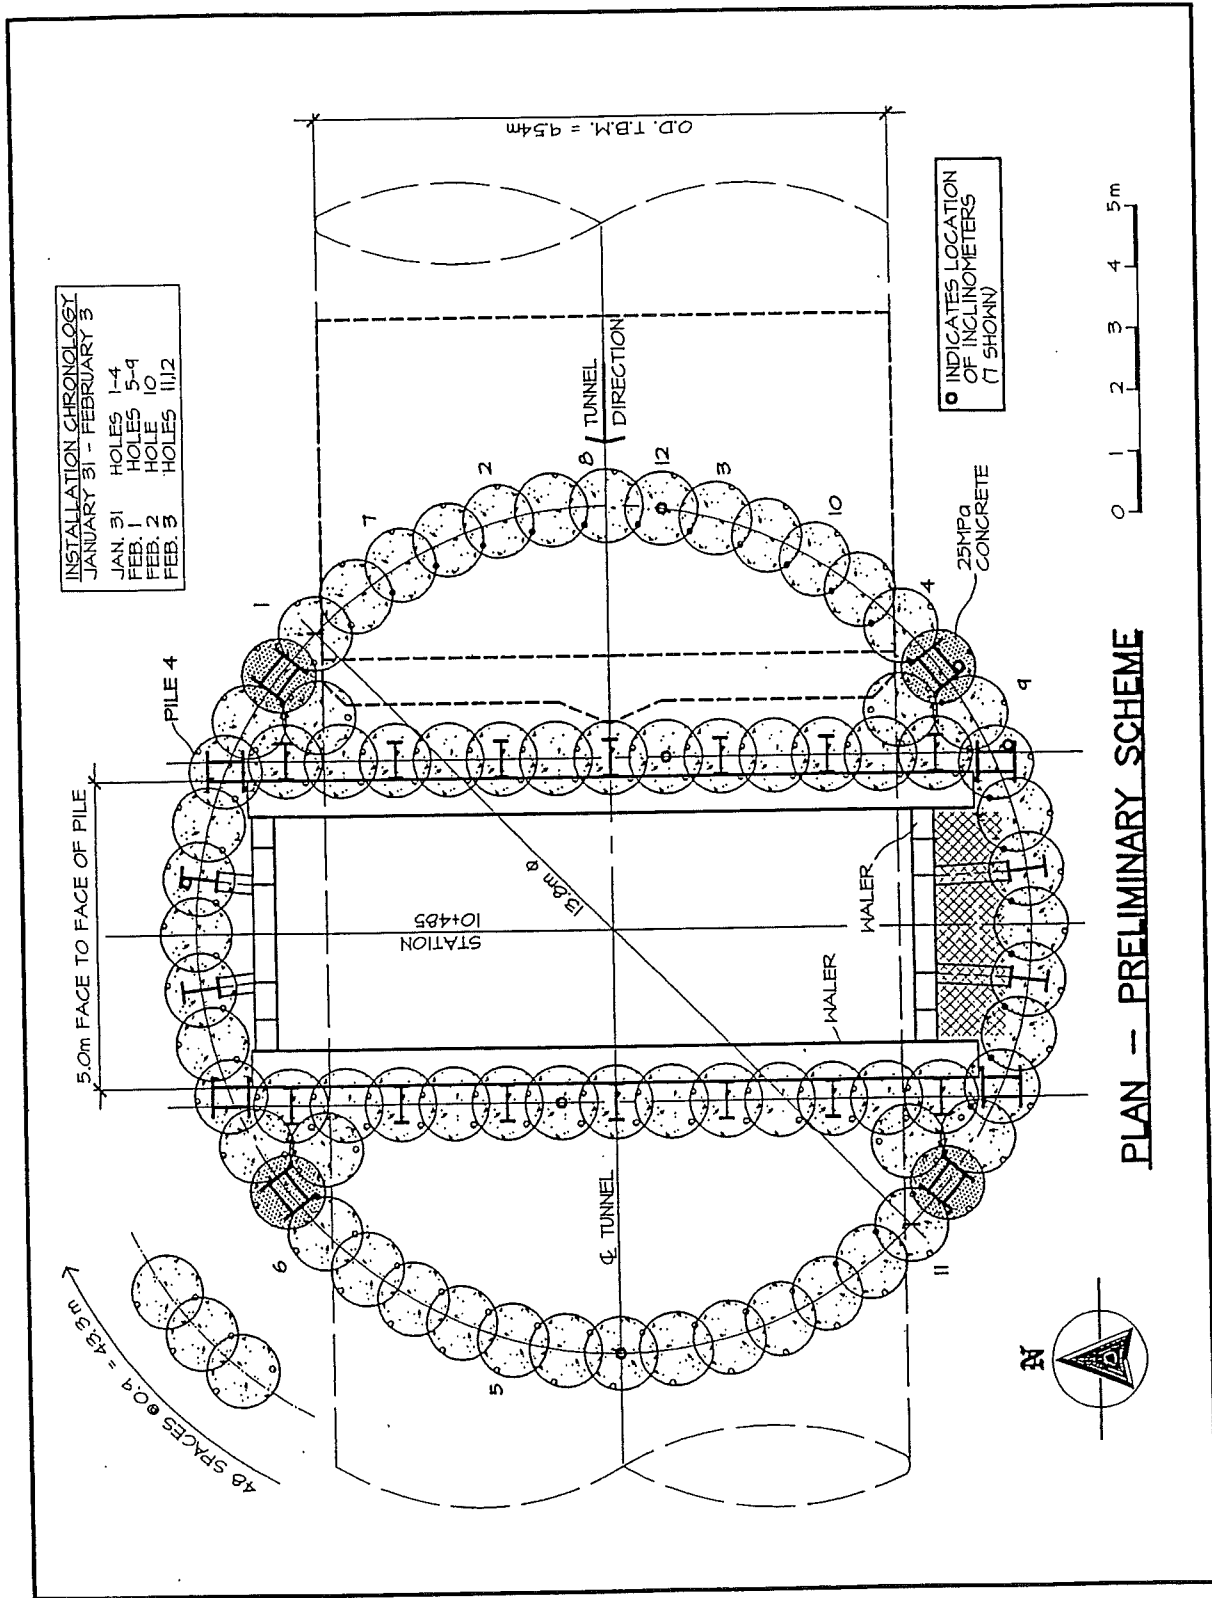
Figure 3: Preliminary Shaft Design

The preliminary design by Isherwood is illustrated on Figure 3 and was based on Deep's schematic sketches. The concept was to create a circular unreinforced compression ring comprising 1.2m diameter interlocked caissons at 0.9m centres as an outer line of defence. The smaller rectangular shaft would be excavated inside this ring employing similar secant wall shoring reinforced with steel beams in every second caisson. The steel beams would terminate above the area to be bored by the TBM. The ring was to be constructed with 5 MPa concrete and intended to reduce soil pressure on the internal cross walls, which could not feasibly support the full soil pressure without strutting. The 'D' shaped areas between the walls were treated as bins, and soil load on the straight walls estimated by bin theory. A tentative plug design comprising a global pattern of 1.5m diameter caissons was included. The total number of caissons in this preliminary design was 78-1.2m and 42-1.5m diameter for a total of 120 caissons.

Various alternative approaches to the drilling methods were tried over the next several days. An open hole closure (or interlock) caisson was attempted on the east side of the shaft (numbered 12 on Figure 3), but encountered saturated collapsing ground.

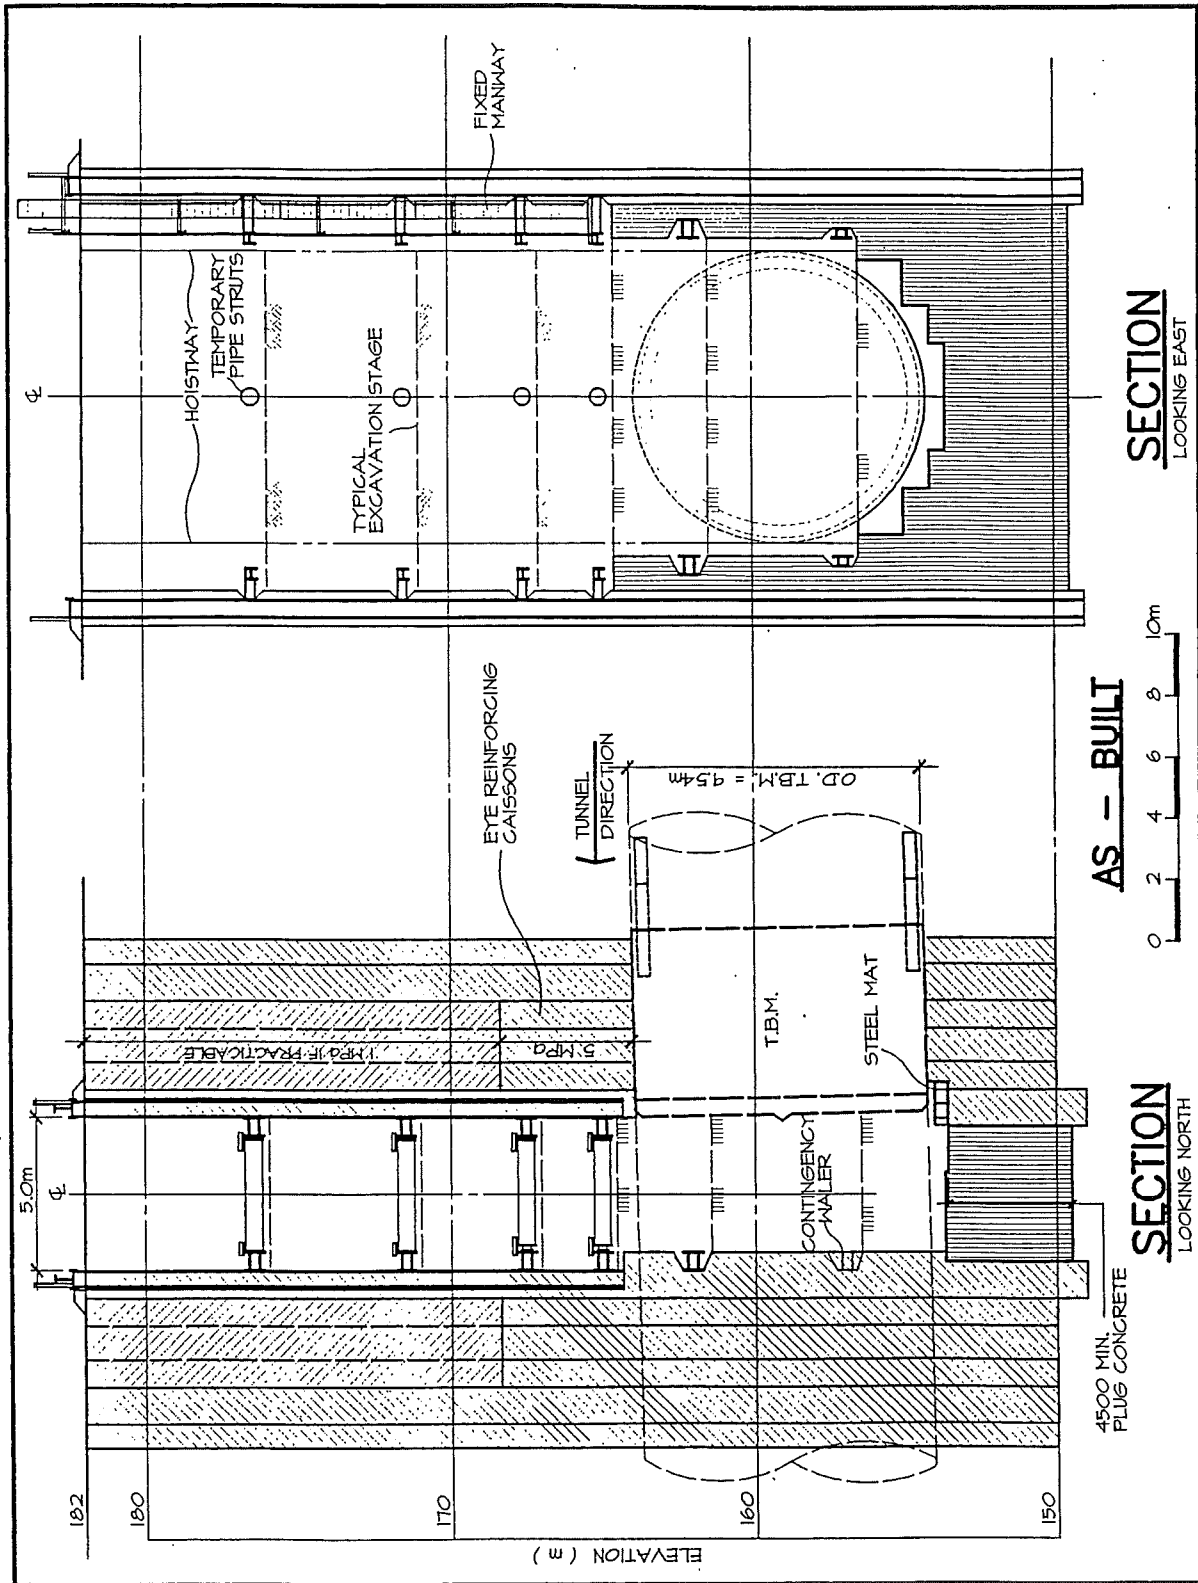
Figure 14: Shaft Sections - As Built

It was decided to raise the TBM to the correct elevation before removing the cutterhead. Explosives were used to create a 0.3m clearance in the shaft concrete above the TBM. This caused "considerable damage" to the machine (Reference 4), but had no apparent affect on the remaining shaft structure. A substantial steel mat was installed under the leading edge to spread load (Figure 14), while the articulation of the machine was used to raise the front of the TBM.

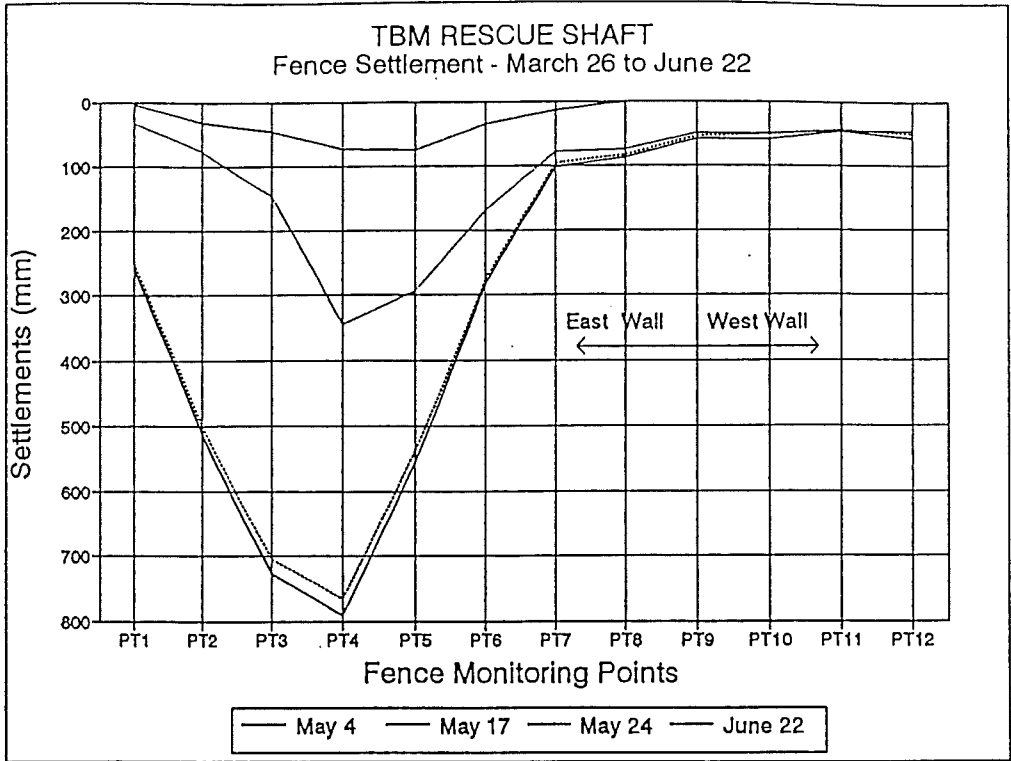
Figure 11: Fence Settlement

Preparation for TBM restart commenced early May, and excavation of the rectangular shaft commenced May 17. The TBM passed under the road on May 17 and drilled into the base of the shaft on May 21. A pronounced settlement trough appeared at the road, and the fence on the west side settled an additional 700mm (Figure 11), for a total settlement of 900mm (Figure 12).

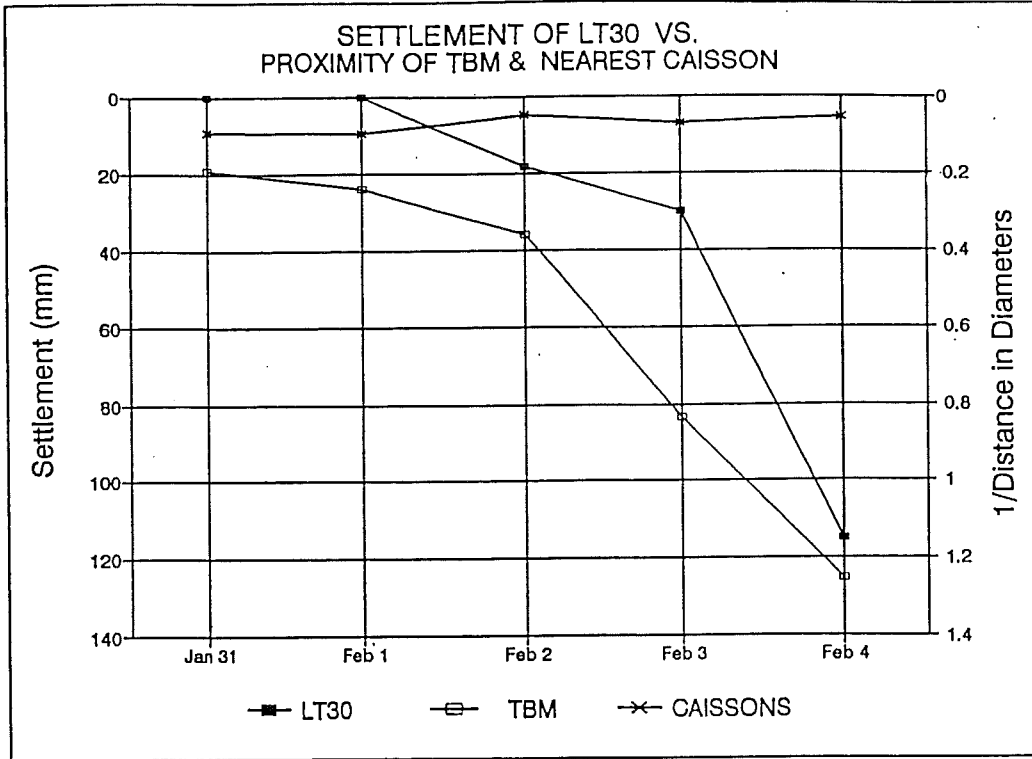
Figure 9: Surface Settlement related to Construction Proximity

Monitoring points along the tunnel centreline showed surface settlement generally in the order of 100mm following passage of the TBM. Point LT30, 7m ahead of the parked position settled

from 30mm to 115mm on Feb 4. It was expressed by others that this drawdown was possibly due to the drilling for the shaft 13m away. Figure 9 compares distance in tunnel diameters and caisson diameters from this point and shows correlation between TBM approach and the settlement.

Other possible causes or contributors were disturbance by the drilling and concreting operations, and electrical disruption of clay bonds either by the electrical system in the original tunnel or the new tunnel.

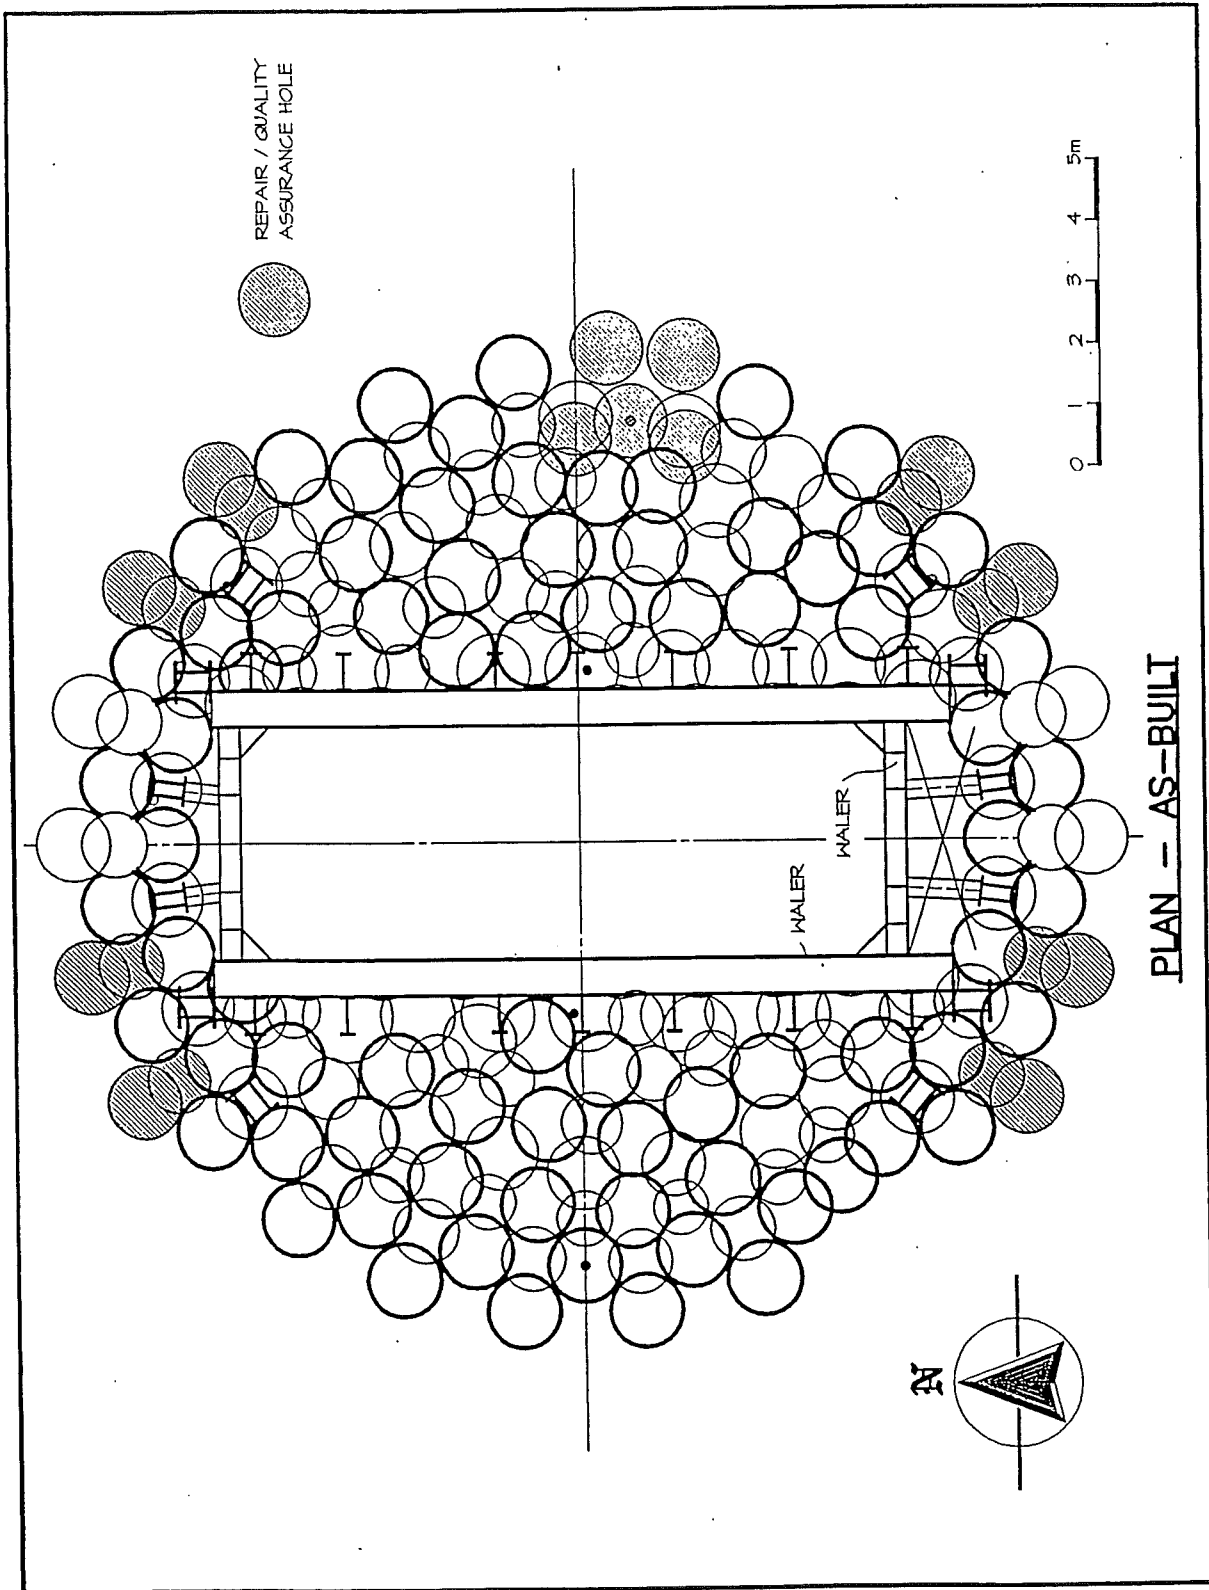
Figure 8: Plan of Shaft As-Built

After the majority of the caissons had been installed and before attempting the excavation, additional measures were reviewed to provide further quality assurance. Much of the concrete supplied had tested significantly below strength, and records of the early installation indicated three caissons of doubtful continuity. In order to remedy these, 29 additional caissons were incorporated as indicated on Figure 8.

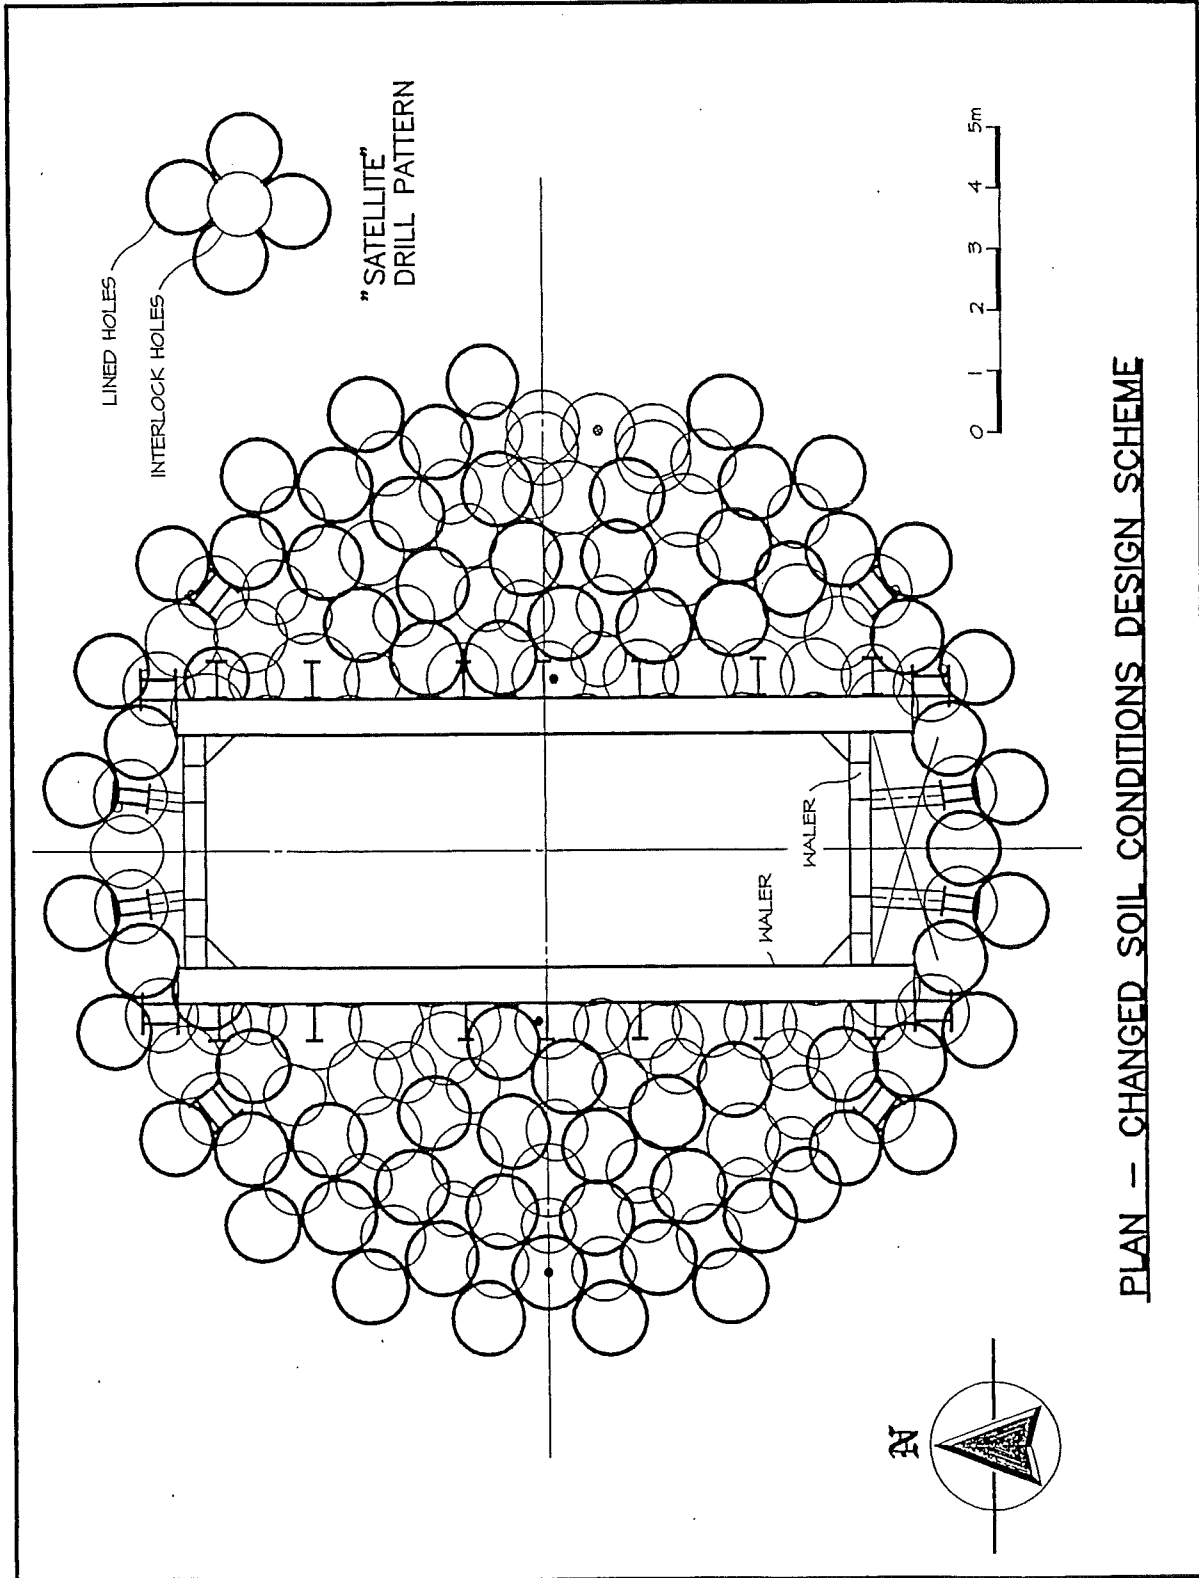
Figure 7: Revised Design for Changed Soil Conditions

The revised design had to consider all the caissons by this time installed, and the resulting complex pattern employed 2-1.5m, 155-1.2m, 20-1.05m and 50-0.9m diameter caissons for a total of 227 caissons (See Figure 7).
